**AIRCRAFT GROUND-FLOTATION INVESTIGATION
PART VI DATA REPORT ON TEST SECTION 3**

**TECHNICAL REPORT AFFDL-TR-66-43, PART VI
AUGUST 1966**

PART VI DATA REPORT ON TEST SECTION 5

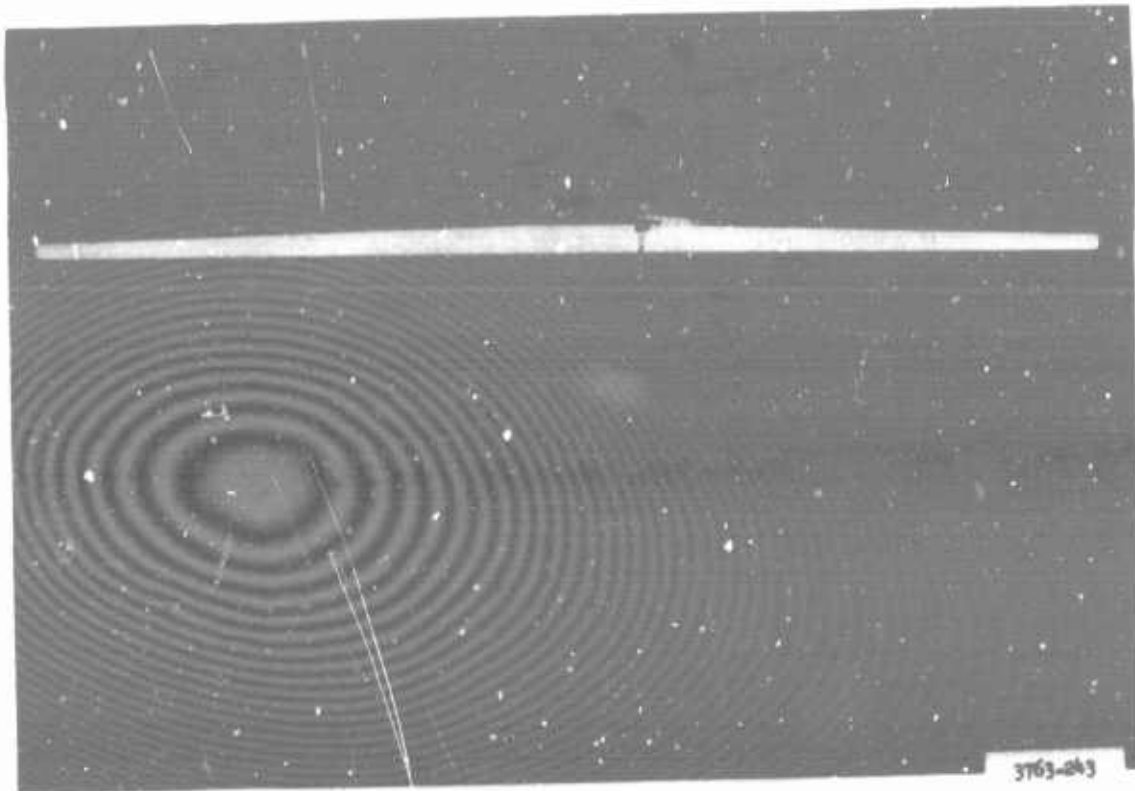
Item 1. Figure 12 shows item 1 prior to traffic. During early trafficking of the item, mat breaks began to develop and differential deformation averaged slightly greater than 1 in. at 19 traffic coverages. The item was considered failed due to roughness at 74 coverages (figures 13 and 14). The rated CBR of the item was 2.6.

Figure 14. Lane 10, item 1. Transverse straightedge shows roughness at 74 coverages (failure)

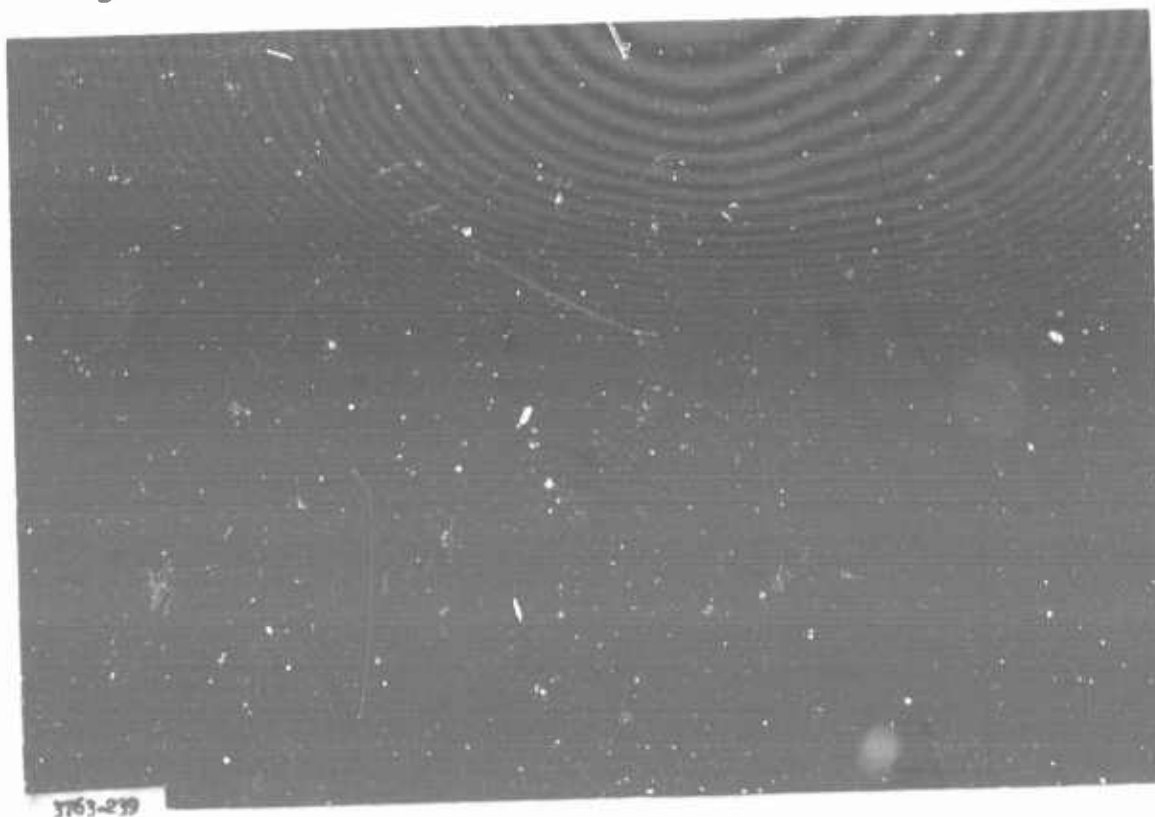
failed due to roughness at 48 coverages due primarily to displacement at the end joints (figures 16 and 17). The rated CBR was 4.0.

Figure 17. Lane 10, item 2. Diagonal straightedge shows roughness at 48 coverages (failure)

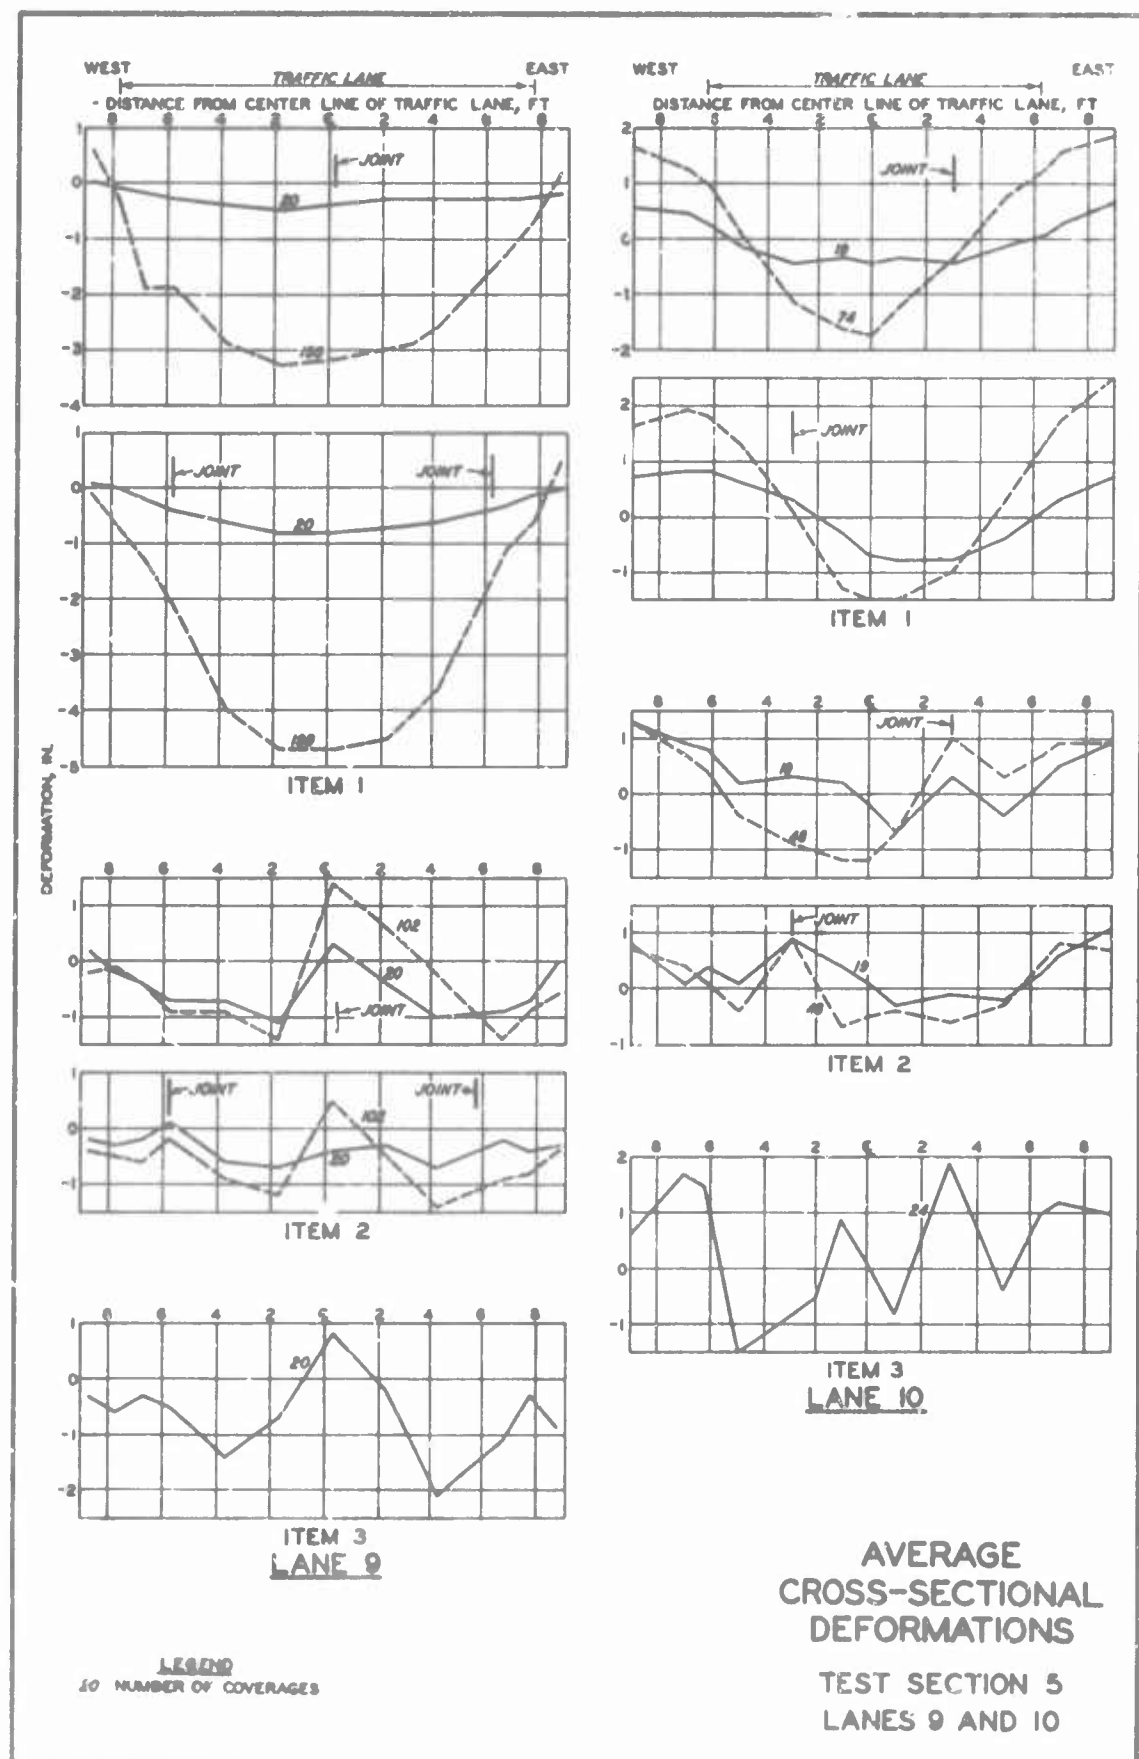
Figure 23

- b. Deformation. Figures 23 and 24, respectively, show average cross-section and profile plots for 20 and 199 coverages. Cross-section measurements for both typical mat runs are shown in figure 23. The deformation plots illustrate the subsidence and troughing effect that existed at failure of the item.

- b. Deformation. Average cross-section plots at 20 and 102 coverages are shown in figure 23 for the two typical mat runs. At failure the center-line surface elevation was higher in both plots than prior to trafficking. A profile along the mat-joint line, 0.25 ft east of the lane center line, is shown in figure 24. The elevation of the mat ends caused when two wheels straddled the mat-joint line is evident at the 20- and 102-coverage levels represented.

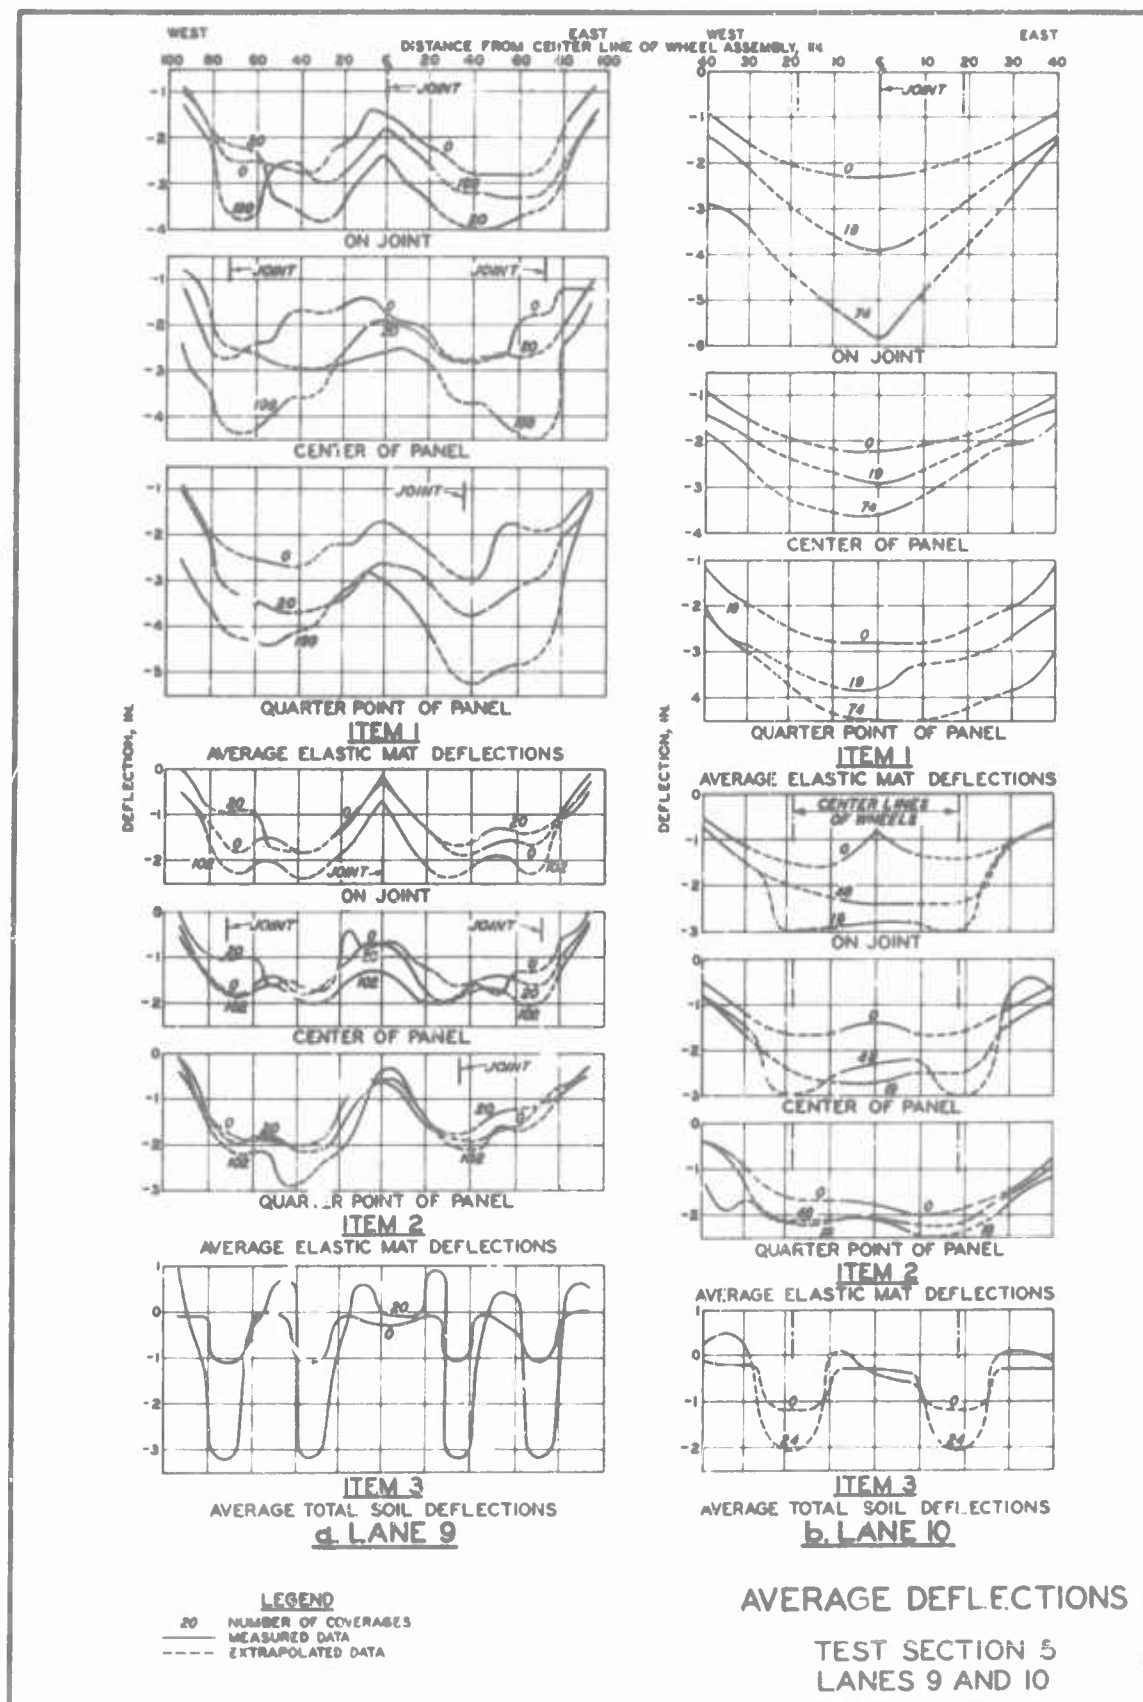
Figure 25

- c. Deflection. Average elastic mat deflections measured at 0, 20, and 199 coverages are shown in figure 25. Plots representing deflections measured with the wheel assembly at three positions relative to mat end joints are shown. Elastic soil deflection directly beneath a load wheel was 1.8 in. at failure.

- c. Deflection. Average elastic mat deflections under static load of the load-wheel assembly for three positions of the assembly relative to mat end joints are plotted in figure 25. Deflection measurements at 0, 19, and 74 coverages are shown. In each plot the deflection curve assumed a shape similar to that of a single-wheel assembly. Elastic soil deflection at failure was 1.7 in.
